Restoration of Anterior Dental Erosion with a Combination of Veneers and Crowns: A 3-Year Case Report

Amara Abreu, DDS, MSD*; M. Bryan Rucker, CDT†; Maria A. Loza, DMD, MS‡; William W. Brackett, DDS, MSD§

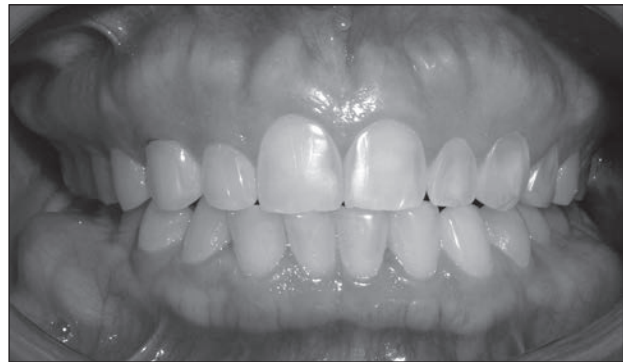
A 40-year-old female presented for consultation with the prosthodontist regarding the appearance of her teeth. She had smooth, eroded facial enamel affecting her maxillary anterior and some of her posterior teeth (Fig. 1).

Figure 1. Initial appearance of patient: loss of tooth structure through erosion, resulting short maxillary canines and central incisors.

Initial therapy consisted of wearing a splint for 2 months and occlusal adjustment to achieve uniform MI contacts and the removal of posterior interferences. New records were taken and a diagnostic wax-up made. Modifications included to increase the lengths and thicknesses of the facial contours of the maxillary anterior teeth, with incisal edge positions based on the position of the lower lip at full smile. The treatment plan included pressed labial veneers on the maxillary right canine, the right lateral, and both central incisors; pressed all-ceramic crowns on the maxillary left lateral incisor, canine, and first premolar of the same quadrant; and a zirconia all-ceramic crown on the maxillary left first molar. A composite on the buccal surface of maxillary left second premolar was also planned.

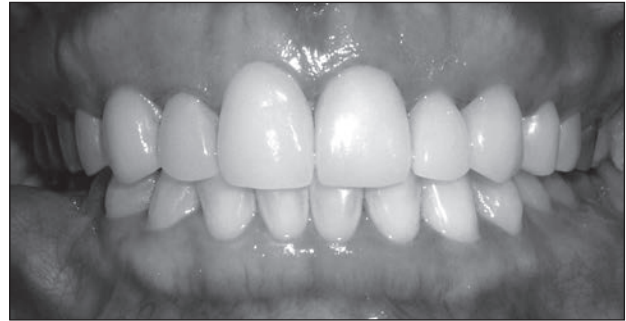
Figure 2. Restorations at 1 month; acceptable shade matching between crown and veneer restorations.

By using try-in paste, the prosthodontist was able to ascertain that the same shade of cement could be used for all the restorations (Yellow; NX3 Nexus®, Kerr Corporation). Cementation, including the treatment of the teeth, was completed according to the manufacturer's recommendations. First, the veneers were inserted using the light-cured version of the resin cement. The ceramic crowns were then cemented using the dual-cured version of the same cement. The occlusion was re-evaluated and the adjusted areas were polished. The patient was given detailed oral hygiene instructions and received a temporary splint 48 hours later (Fig. 2).

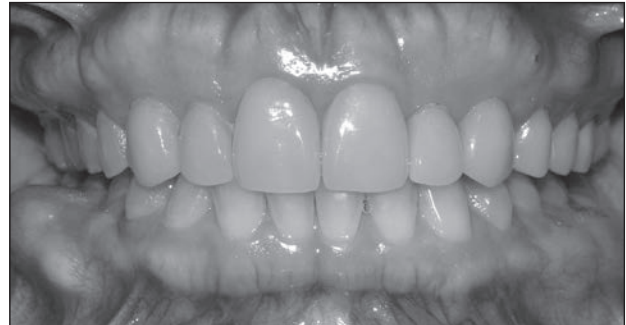
The patient has been seen for annual recalls since the insertion date. No shade mismatch is evident between the veneers and adjacent crowns, and the occlusion is stable (Fig. 3).

Figure 3. Restorations at 3 years; esthetic appearance maintained.
